**Hyundai Santa Fe**  
Standard Safety Equipment

2018

Tested Model	Hyundai Santa Fe 2.2CRDi, LHD
Body Type	- 5 door SUV
Year Of Publication	2018
Kerb Weight	1950kg
VIN From Which Rating Applies	- all Santa Fe
Class	Large Off-Road

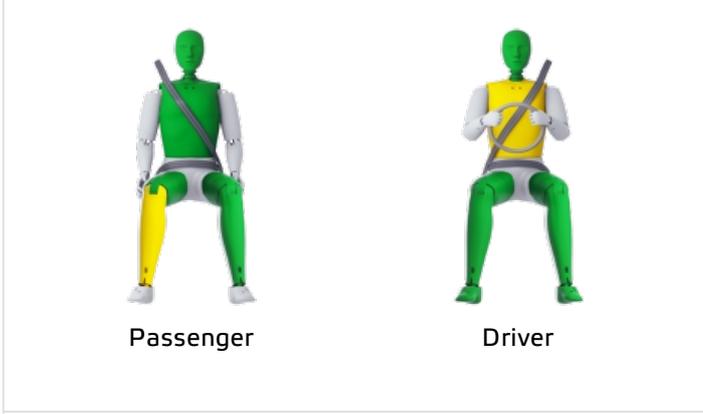
Frontal Offset Deformable Barrier 7.9 / 8 Pts

Passenger                      Driver

Detailed description: This panel shows two crash test dummies. The Passenger dummy is shown from the front-left, with a yellow leg indicating 'ADEQUATE' performance. The Driver dummy is shown from the front-right, with a yellow torso indicating 'ADEQUATE' performance.

The passenger compartment remained stable in the frontal offset test. Dummy readings indicated good protection of the knees and femurs of both the driver and passenger dummies. Hyundai showed that a similar level of protection would be provided to occupants of different sizes and to those sitting in different positions. In the full-width rigid barrier test, protection of all critical body areas was good for the driver and good or adequate for the rear passenger. In the side barrier test, dummy readings indicated good protection of the driver. However, the side curtain airbag got caught on the trim of the C-pillar and did not deploy as intended. Moreover, the airbag was seen to have torn during deployment. Hyundai investigated the tear and have changed the airbag attachment fixings of affected vehicles in production and have issued a recall for all vehicles with a panoramic roof. Owners are encouraged to take their vehicles to dealers when asked to do so. The side barrier test was repeated with changed airbag attachment fixings and no tearing was seen. However, the airbag still did not deploy as intended and protection of the driver's head, in the side barrier and side pole tests, was downgraded to adequate. Tests on the front seats and head restraints demonstrated good protection against whiplash injuries in the event of a rear-end collision. However, a geometric assessment of the rear seats indicated poor whiplash protection. The standard-fit autonomous emergency braking (AEB) system performed well in tests of its functionality at the low speeds, typical of city driving, at which many whiplash injuries are caused.

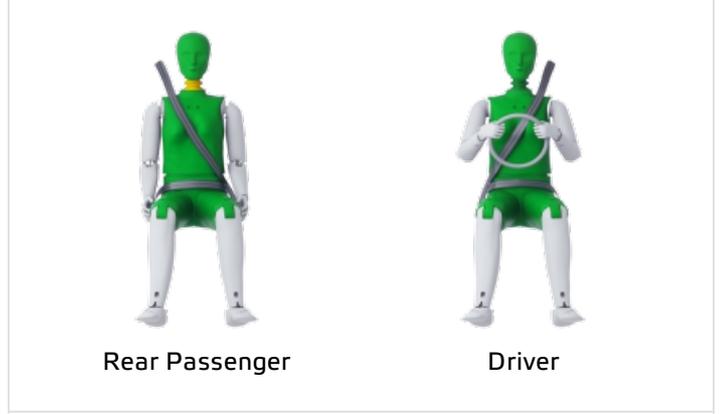
Frontal Full Width 7.8 / 8 Pts

Rear Passenger                      Driver

Detailed description: This panel shows two crash test dummies. The Rear Passenger dummy is shown from the front-left, with a green torso indicating 'GOOD' performance. The Driver dummy is shown from the front-right, with a green torso indicating 'GOOD' performance.

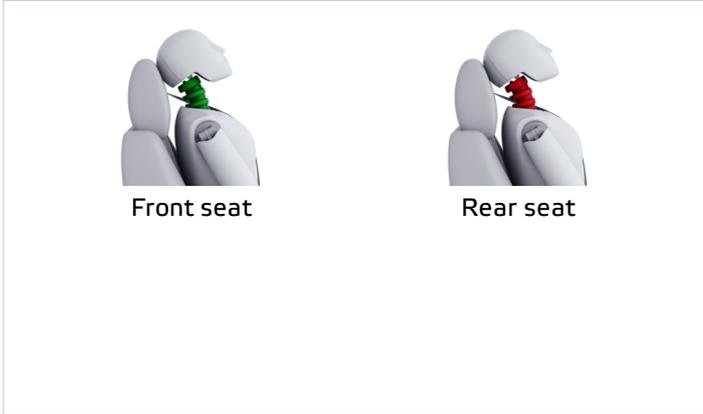
Whiplash Rear Impact 1.3 / 2 Pts

Front seat                      Rear seat

Detailed description: This panel shows two neck and head models. The Front seat model has a green neck indicating 'GOOD' performance. The Rear seat model has a red neck indicating 'POOR' performance.

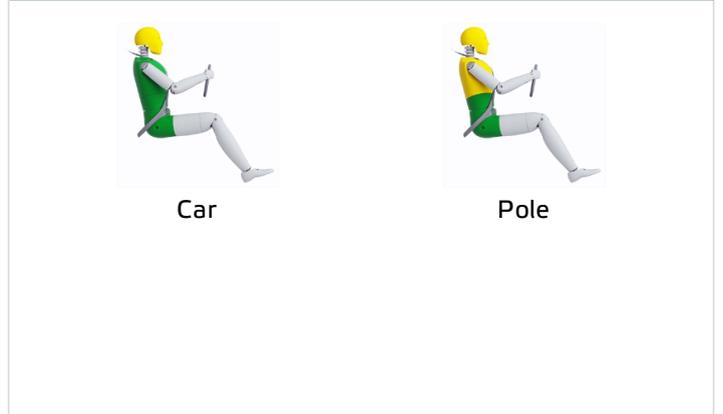
Lateral Impact 14.8 / 16 Pts

Car                      Pole

Detailed description: This panel shows two side-impact crash test dummies. The Car dummy is shown from the side, with a green torso indicating 'GOOD' performance. The Pole dummy is shown from the side, with a yellow torso indicating 'ADEQUATE' performance.

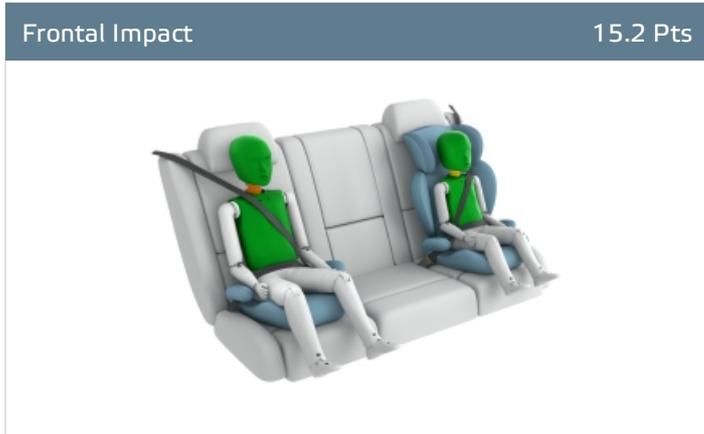
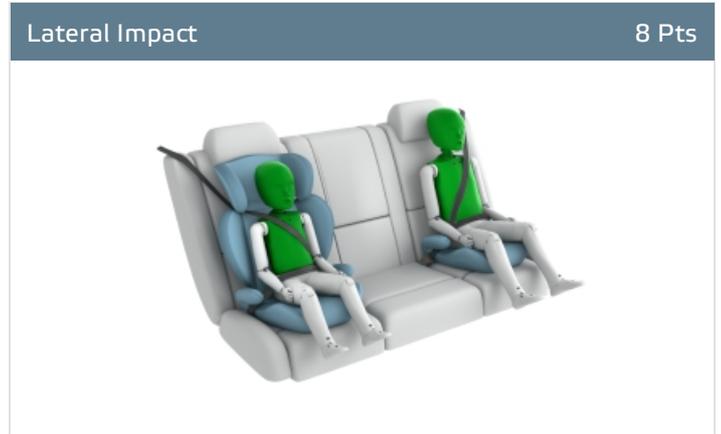
Crash Test Performance based on 6 & 10 year old children

Restraint for 6 year old child: *Britax Römer KidfixXP II SICT*  
 Restraint for 10 year old child: *Booster Cushion*

In the frontal offset test, protection of all critical body areas was good or adequate, except the neck of the 10 year dummy, protection of which was rated as marginal, based on dummy readings of neck tension. In the side barrier test, protection was good for all critical body areas. The front passenger airbag can be disabled to allow a rearward-facing child restraint to be used in that seating position. Clear information is provided to the driver regarding the status of the airbag and the system was rewarded. All of the restraint types for which the Santa Fe is designed could be properly installed and accommodated in the car.
