TEST RESULTS

Citroën C3 Standard Safety Equipment

Tested Model	Citroën C3 1,2 PureTech 82 FEEL, LHD
Body Type	- 5 door hatchback
Year Of Publication	2017
Kerb Weight	1072kg
VIN From Which Rating Applies	- all C3s
Class	Supermini

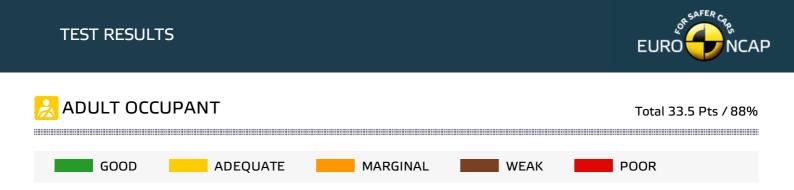
<u> ADULT OCCUPANT</u>

Total 33.5 Pts / 88%

The passenger compartment of the C3 remained stable in the frontal offset test. Dummy readings indicated good protection of the knees and femurs for the driver and passenger. Citroën showed that a similar level of protection would be provided to occupants of different sizes and to those sat in different seating positions. In the full-width rigid barrier test, protection of the chest and neck was adequate for the driver and rear passenger, and that of other critical body areas was good. The C3 scored maximum points for its performance in the side barrier test, with good protection of all critical parts of the body. Even in the more severe side pole impact, protection against whiplash injury in the event of a rear-end collision, and a geometric assessment of the rear seats showed good protection there, too. The C3 does not have an autonomous emergency braking system.

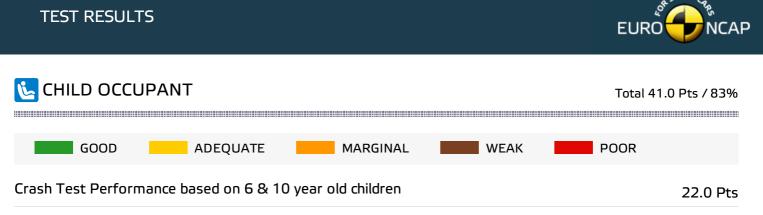
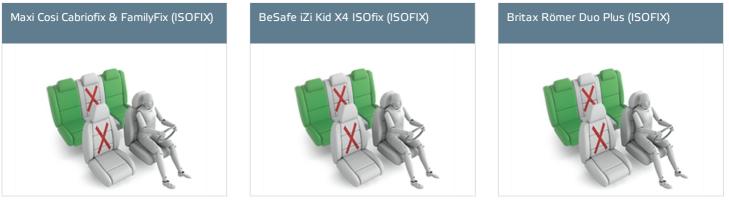
🔄 CHILD OCCUPANT

Total 41.0 Pts / 83%

In the frontal offset test, readings of neck tension in the 10 year dummy, and of chest deceleration in the 6 year dummy indicated a marginal level of protection. Otherwise, protection was adequate or good. In the side barrier test, protection was good for all critical parts of the body. The front passenger airbag can be disabled to allow a rearward-facing child restraint to be used in that seating position. Clear information is provided to the driver and the system was rewarded. All of the restraint types for which the C3 is designed could be properly installed and accommodated in the car.
