Volvo V60
Standard Safety Equipment

2018

SPECIFICATION

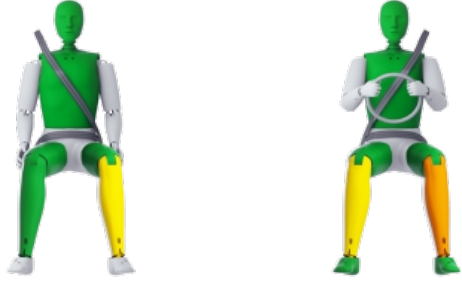
Frontal Offset Deformable Barrier 7.3 / 8 Pts

The passenger compartment of the V60 remained stable in the frontal offset test. Dummy readings indicated good protection of the knees and femurs of the driver and passenger. Volvo showed that a similar level of protection would be provided to occupants of different sizes and to those sitting in different positions. In the full-width rigid barrier test, protection of the neck and chest was adequate for the rear passenger, and protection of other critical body areas was good. For the driver, protection was good for all critical body regions. In both the side barrier impact and the more severe side pole test, protection of critical parts of the body was good or adequate. Tests on the front seats and head restraints demonstrated good protection against whiplash injuries in the event of a rear-end collision. A geometric assessment of the rear seats also indicated good whiplash protection. The standard-fit autonomous emergency braking system performed well in tests of its functionality at the low speeds, typical of city driving, at which many whiplash injuries are caused.

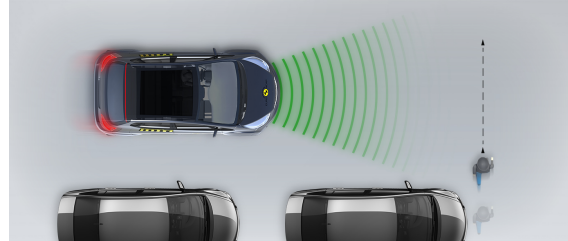
Child running from behind parked vehicles

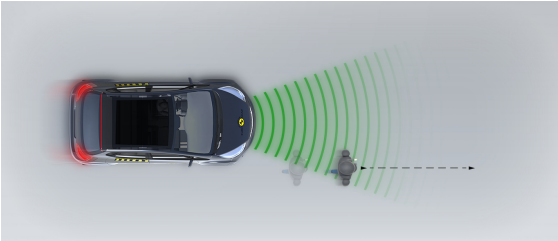
Adult along the roadside

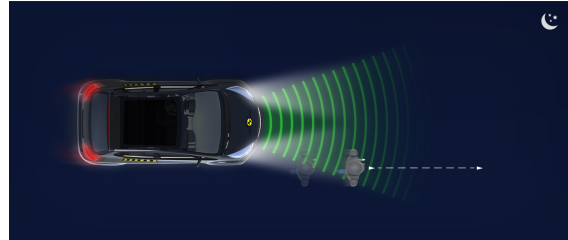
Adult along the roadside
