## Peugeot 508

Standard Safety Equipment

2018

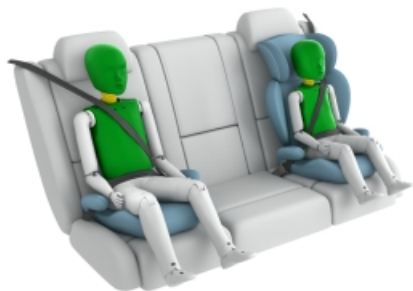
Frontal Impact

15.4 Pts

In the frontal offset and side barrier tests, protection of the 6 and 10 year dummies was good or adequate for all critical body areas. The front passenger airbag can be disabled to allow a rearward-facing child restraint to be used in that seating position. Clear information is provided to the driver regarding the status of the airbag and the system was rewarded. All of the restraint types for which the 508 is designed could be properly installed and accommodated in the car.
