Mercedes-Benz B-Class
Standard Safety Equipment

2019

Tested Model	Mercedes-Benz B 180 - Progressive Line, LHD
Body Type	- 5 door MPV
Year Of Publication	2019
Kerb Weight	1405kg
VIN From Which Rating Applies	- WDD2470122J053058
Class	Small MPV

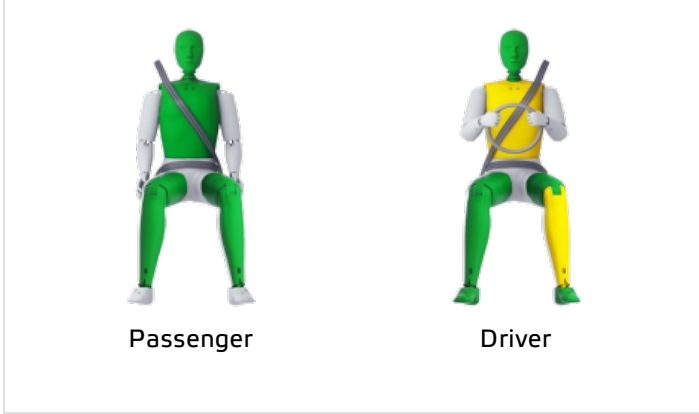
Frontal Offset Deformable Barrier 7.7 / 8 Pts

Passenger Driver

Detailed description: This panel shows the results for the Frontal Offset Deformable Barrier test. It features two side-view illustrations of a crash test dummy seated in a car. The Passenger dummy is entirely green, indicating a 'GOOD' result. The Driver dummy is yellow and green, indicating an 'ADEQUATE' result.

In the frontal offset test, the passenger compartment of the B-Class remained stable. Dummy readings indicated good protection of the knees and femurs of both the driver and passenger. Mercedes-Benz showed that a similar level of protection would be provided to occupants of different sizes and to those sitting in different positions. Protection of the front passenger was good for all critical body areas. In the full-width rigid barrier test, protection of the driver was good or adequate for all critical body areas. For the rear passenger, dummy readings of chest compression indicated marginal protection for that body area but protection was otherwise good or adequate. In the side barrier impact, protection was good for all body areas and the car scored maximum points. In the more severe side pole test, protection of the chest was adequate and that of other critical body areas was good. Tests on the front seats and head restraints demonstrated good protection against whiplash injuries in the event of a rear-end collision. A geometric assessment of the rear seats also indicated good whiplash protection. The standard-fit autonomous emergency braking (AEB) system performed well in tests of its functionality at the low speeds at which many whiplash injuries occur.

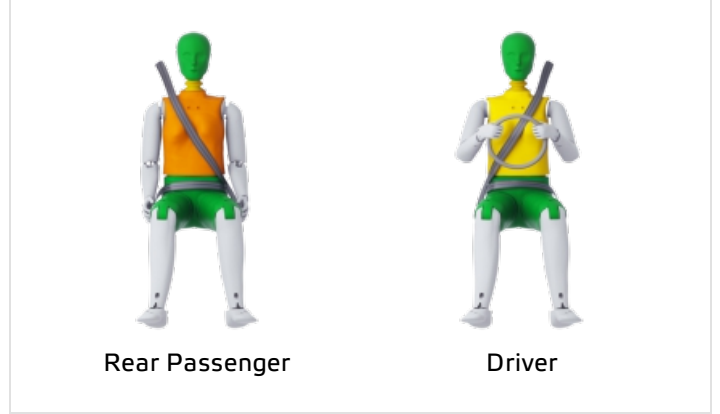
Frontal Full Width 7.5 / 8 Pts

Rear Passenger Driver

Detailed description: This panel shows the results for the Frontal Full Width test. It features two side-view illustrations of a crash test dummy seated in a car. The Rear Passenger dummy is orange and green, indicating a 'MARGINAL' result. The Driver dummy is yellow and green, indicating an 'ADEQUATE' result.

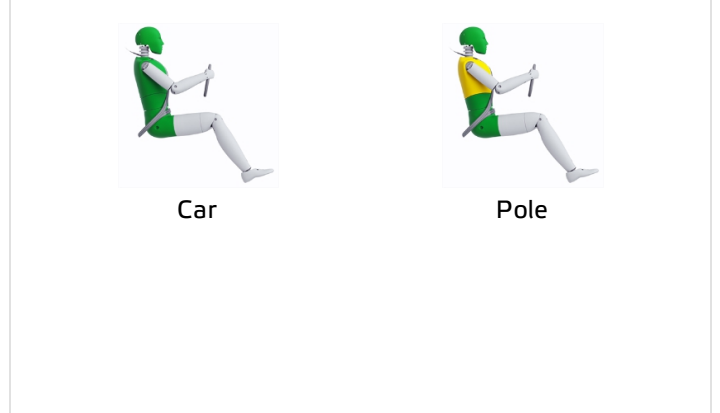
Lateral Impact 15.9 / 16 Pts

Car Pole

Detailed description: This panel shows the results for the Lateral Impact test. It features two side-view illustrations of a crash test dummy seated in a car. The Car dummy is green, indicating a 'GOOD' result. The Pole dummy is yellow and green, indicating an 'ADEQUATE' result.

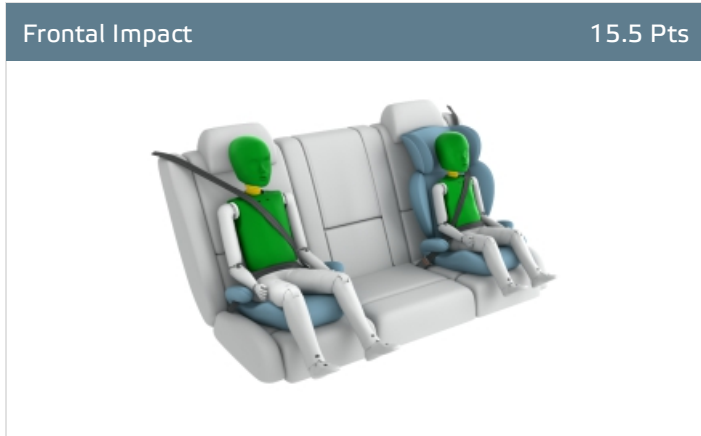
23.5 / 24 Pts

Crash Test Performance based on 6 & 10 year old children

Restraint for 6 year old child: *Mercedes-Benz Kidfix XP*
 Restraint for 10 year old child: *Booster Cushion*

In the frontal offset test, protection of both the 6 and 10 year dummies was good or adequate for all critical body areas. In the side barrier test, protection was good for both dummies and the car scored maximum points for this part of the assessment. The front passenger airbag is automatically disabled when a rearward-facing child restraint is put in that seating position. Tests showed that the system worked robustly and the system was rewarded. All of the child restraint types for which the B-Class is designed could be properly installed and accommodated.

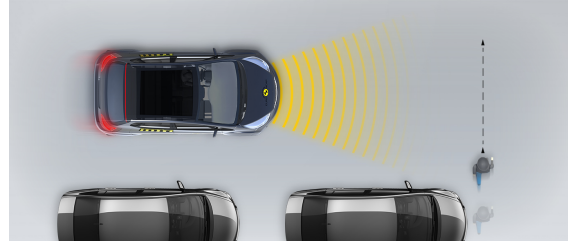
Child running from behind parked vehicles

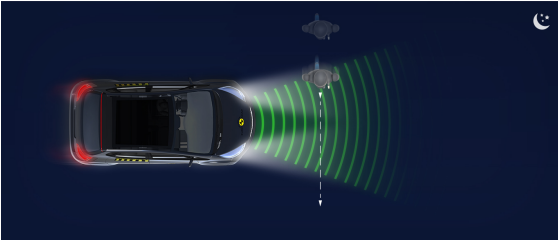
Adult crossing the road
