**Ford Puma**  
Standard Safety Equipment

2019 ★★★★★

## SPECIFICATION

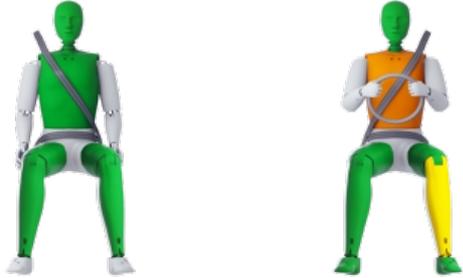
**Frontal Offset Deformable Barrier** 7 / 8 Pts

Passenger                      Driver

The passenger compartment of the Puma remained stable in the frontal offset test. Dummy readings indicated good protection of the knees and femurs of the driver and passenger. Ford showed that a similar level of protection would be provided to occupants of different sizes and to those sitting in different positions. Protection of the driver's chest was rated as marginal. In the full-width rigid barrier test, protection of all critical body areas was good or adequate for both the driver and rear passenger. In both the side barrier and the more severe side pole tests, protection of all critical body areas was good and the car scored full points in both of these tests. Tests on the front seats and head restraints demonstrated good protection against whiplash injuries in the event of a rear-end collision. A geometric assessment of the rear seats also indicated good whiplash protection. The standard-fit autonomous emergency braking (AEB) system performed well in tests of its functionality at the low speeds at which many whiplash injuries occur, with collisions avoided or mitigated in all test scenarios.

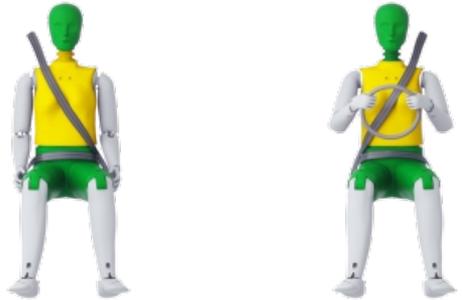
**Frontal Full Width** 7.5 / 8 Pts

Rear Passenger                      Driver

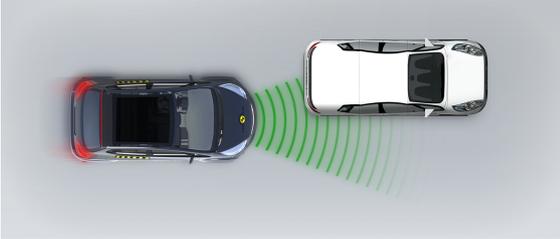
Approaching a stationary car: Left Offset

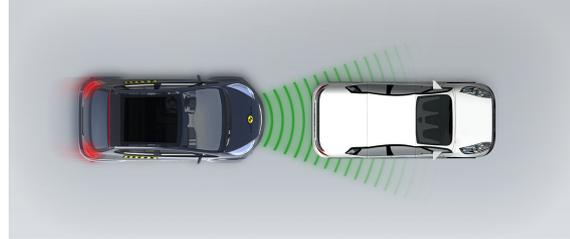
Approaching a stationary car: No Offset

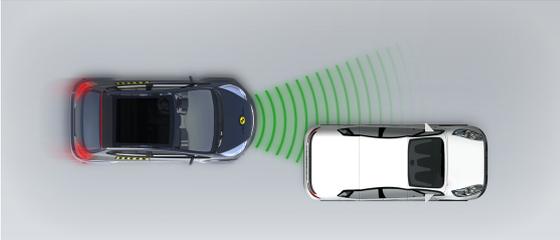
Approaching a stationary car: Right Offset

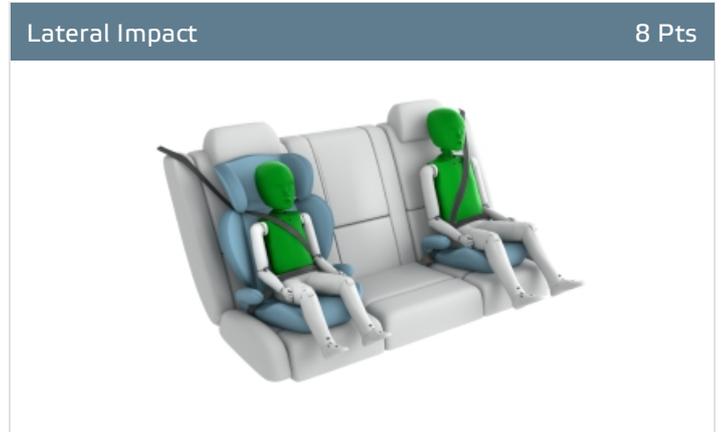
Crash Test Performance based on 6 & 10 year old children

22.5 / 24 Pts

Restraint for 6 year old child: *Britax Römer Kid Fix*  
 Restraint for 10 year old child: *Booster Cushion*

In both the frontal and side barrier tests, protection of all critical body areas was good or adequate for both dummies. The front passenger airbag can be disabled to allow a rearward-facing child restraint to be used in that seating position. Clear information is provided to the driver regarding the status of the airbag and the system was rewarded. All restraints types for the which the Puma is designed could be properly installed and accommodated.

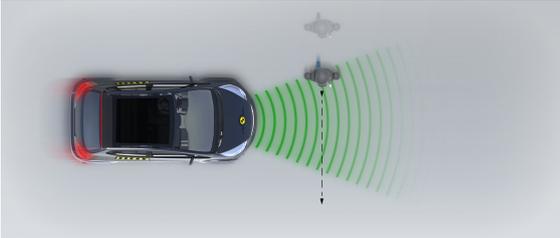
Adult crossing the road

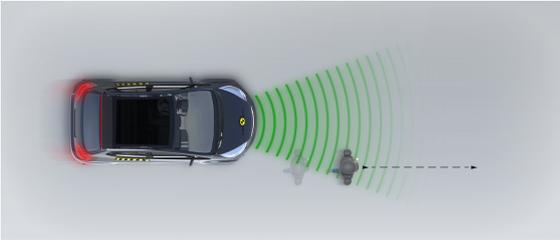
Adult along the roadside

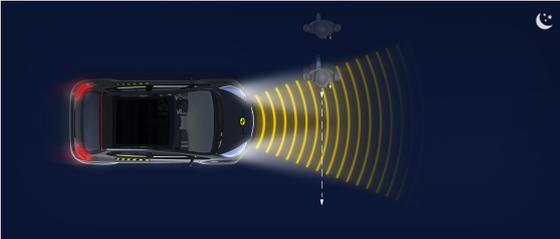
Adult crossing the road

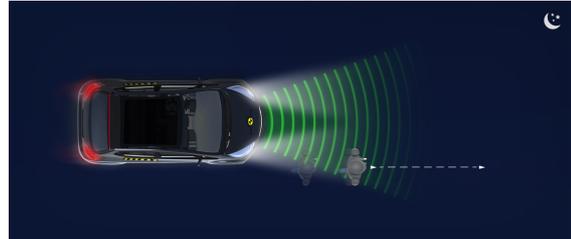
Adult along the roadside

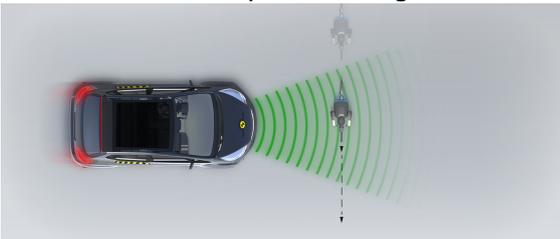
Cyclist crossing

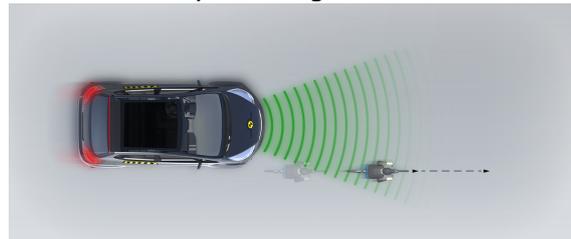
Cyclist along the roadside

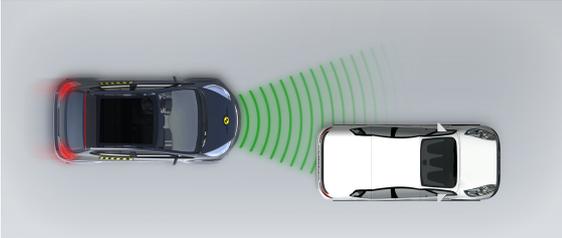
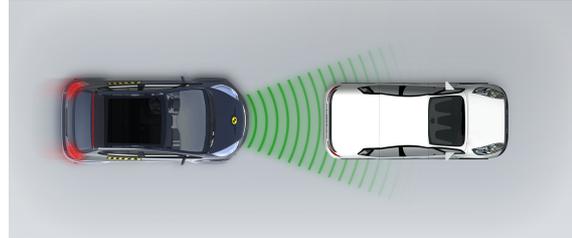
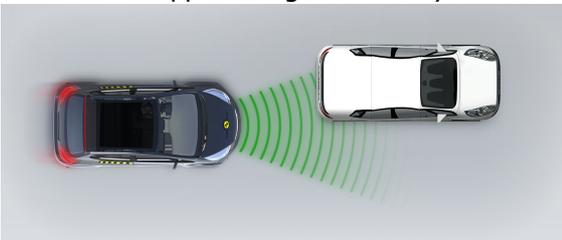
Approaching a stationary car

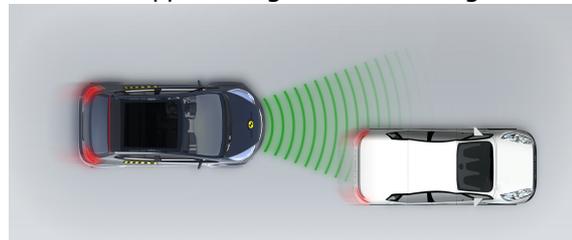
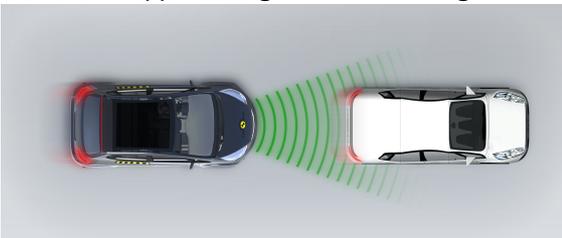
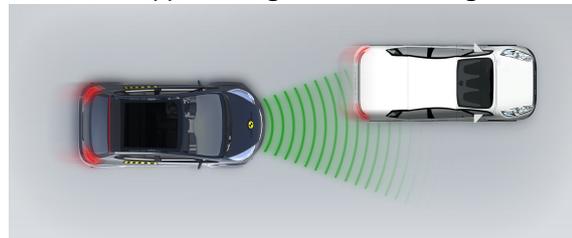
Approaching a slower moving car

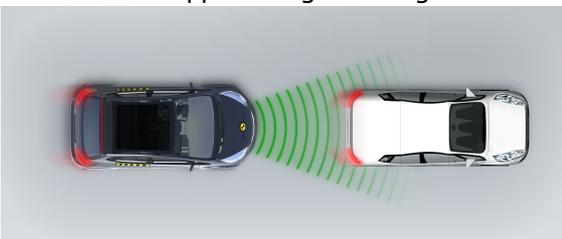
Approaching a braking car
