BMW 2 Series Coupé
Standard Safety Equipment

2022

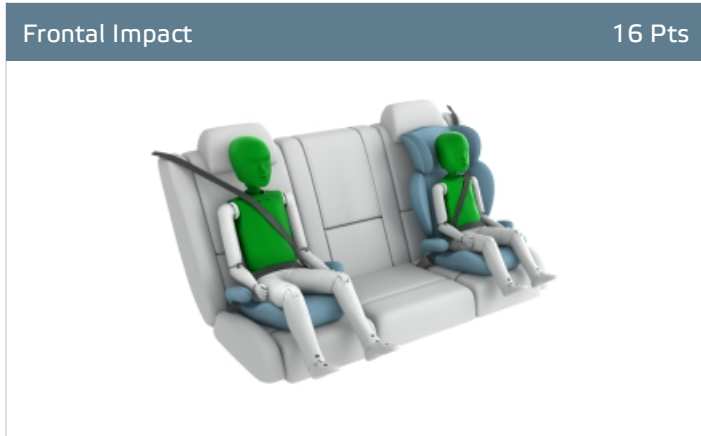
Crash Test Performance based on 6 & 10 year old children

22.1 / 24 Pts

Restraint for 6 year old child: *Britax Römer Kidfix SL*
 Restraint for 10 year old child: *Osann Up booster cushion*

In the side barrier impact, measurements of accelerations in the head of the 10-year dummy indicated weak protection. Otherwise, protection of all critical body areas was good, both for the 10-year and 6-year dummies. The front passenger airbag can be disabled to allow a rearward-facing child restraint to be used in that seating position. Clear information is provided to the driver regarding the status of the airbag and the system was rewarded. All of the restraint types for the which the 2 Series Coupé is designed could be properly installed and accommodated in the car.
