Volkswagen Polo
Standard Safety Equipment

2022

Tested Model	VW Polo, 1.5TSI 'Life', LHD
Body Type	- 5 door hatchback
Year Of Publication	2022
Kerb Weight	1158kg
VIN From Which Rating Applies	- all Polos
Class	Supermini

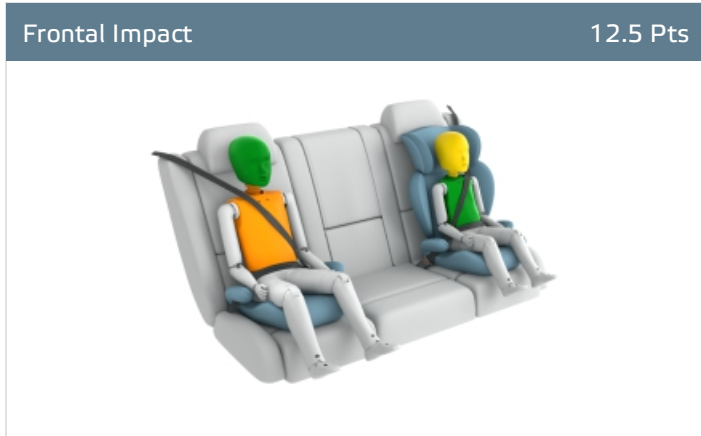
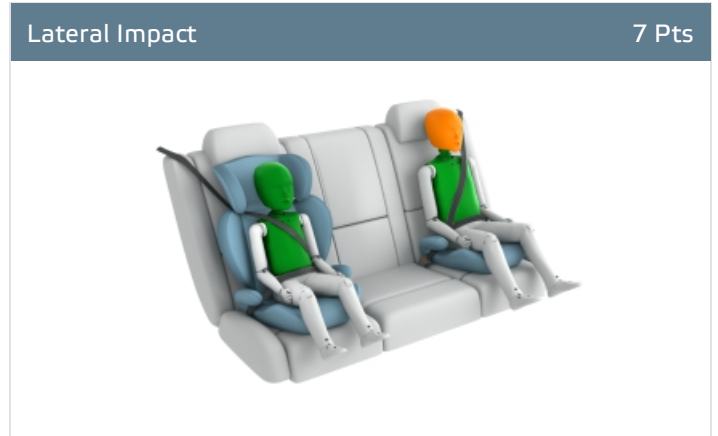
Crash Test Performance based on 6 & 10 year old children

Restraint for 6 year old child: *Volkswagen Isofix G2-3*
 Restraint for 10 year old child: *Volkswagen Isofix G2-3*

In the frontal offset test, dummy measurements indicated marginal protection of the head and chest of the 10-year dummy, and adequate protection of the head and neck of the 6-year dummy. In the side barrier test, protection of the head of the 10-year dummy was rated as marginal, based on measured values of acceleration. The front passenger airbag can be disabled to allow a rearward-facing child restraint to be used in that seating position. Clear information is provided to the driver regarding the status of the airbag and the system was rewarded. All of the restraint types for the which the Polo is designed could be properly installed and accommodated in the car.

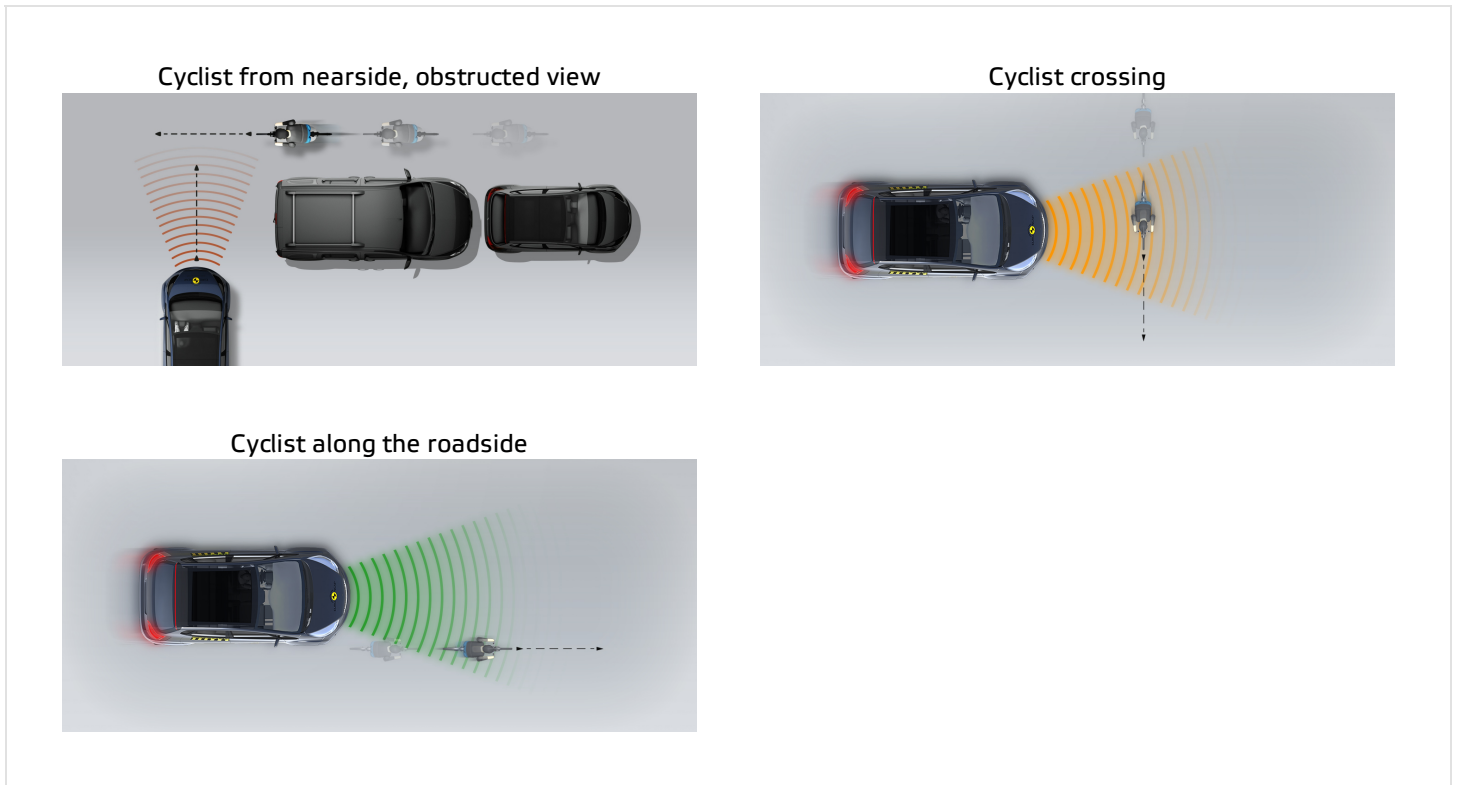
AEB Cyclist

**4.8 / 9 Pts**

The protection provided to the head of a struck pedestrian was predominantly good or adequate, with some poor results recorded on the still windscreen pillars. The bumper provided good protection to pedestrians' legs at all test points. Protection of the pelvis was also good over most of the car width. The autonomous emergency braking system, fitted as standard, can detect vulnerable road users as well as other vehicles. The system performed adequately in tests of its reaction to pedestrians and cyclists, with collisions avoided or mitigated in many scenarios.

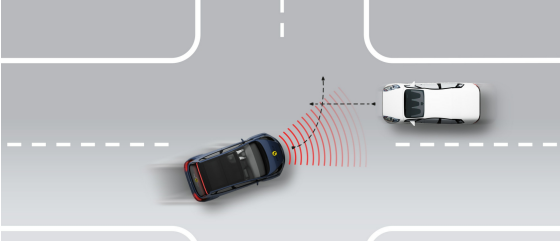
Test car turns across the path of an approaching car

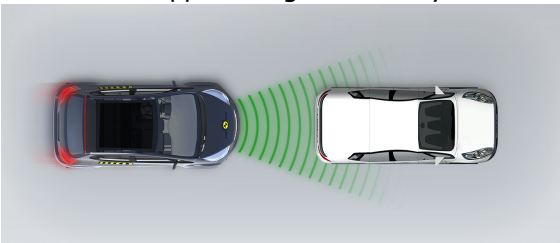
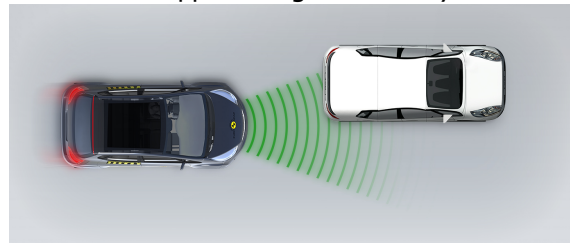
Approaching a stationary car

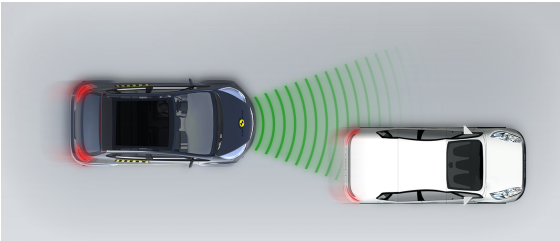
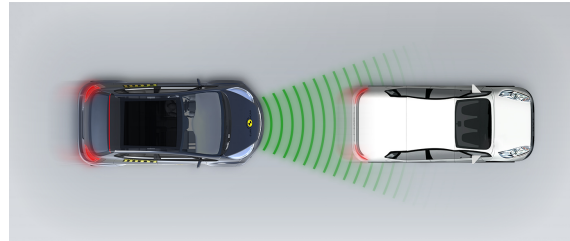
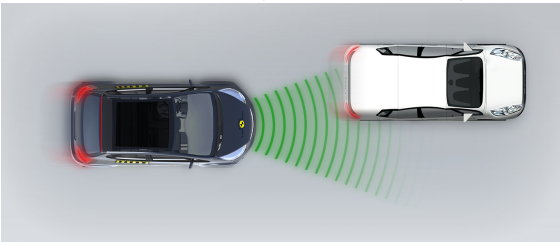
Approaching a slower moving car

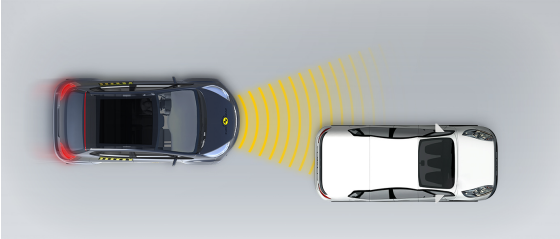
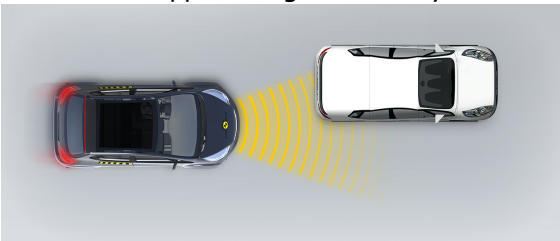
Approaching a stationary car
