2022

Tested Model	VW Polo, 1.5TSI 'Life', LHD
Body Type	- 5 door hatchback
Year Of Publication	2022
Kerb Weight	1216kg
VIN From Which Rating Applies	- all Taigos
Class	Small Off-Road

The Taigo is structurally identical to the VW Polo, and shares the same level of safety equipment. Additional tests have been performed where slight differences might exist and to verify the performance of the Taigo against that of the Polo. Otherwise, test results are taken from the VW Polo 2022 assessment.

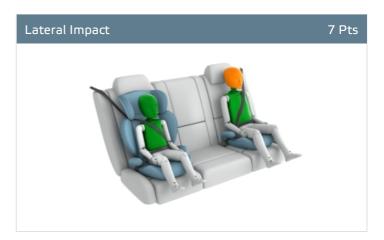
Crash Test Performance based on 6 & 10 year old children

21.2 / 24 Pts

Restraint for 6 year old child: *Volkswagen Isofit G2-3* Restraint for 10 year old child: *Volkswagen Isofit G2-3*

In the frontal offset test, dummy measurements indicated adequate protection of the neck and chest of the 10-year dummy, and adequate protection of the head and neck of the 6-year dummy. In the side barrier test, protection of the head of the 10-year dummy was rated as marginal, based on measured values of acceleration. The front passenger airbag can be disabled to allow a rearward-facing child restraint to be used in that seating position. Clear information is provided to the driver regarding the status of the airbag and the system was rewarded. All of the restraint types for the which the Taigo is designed could be properly installed and accommodated in the car.
