Dacia Jogger
Standard Safety Equipment

2021

Tested Model	Dacia Sandero Stepway 1.0TCe, LHD
Body Type	- 5 door hatchback
Year Of Publication	2021
Kerb Weight	1111kg
VIN From Which Rating Applies	- all Joggers
Class	Supermini

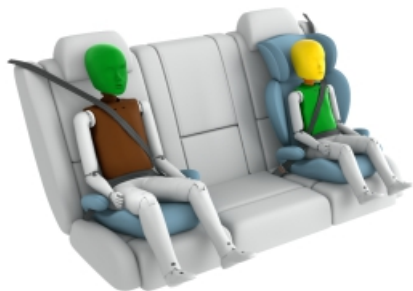
Frontal Impact

10.6 Pts

In the frontal offset test, protection of the chest and neck of the 10 year dummy was rated as weak, based on dummy readings during the impact. For the 6 year dummy, protection of the neck was marginal while that of the head and chest was adequate and good respectively. The front passenger airbag can be disabled to allow a rearward-facing child restraint to be used in that seating position. Clear information is provided to the driver regarding the status of the airbag and the system was rewarded. One CRS, a full sized rearward facing toddler restraint, could be fitted in the car with no problem but was deemed a fail because Dacia indicate in the user manual that the car cannot accommodate this (R3) category of restraint. One type of universal restraint could not be properly fitted in the optional third row seats. Otherwise, restraint systems could be installed and accommodated properly.

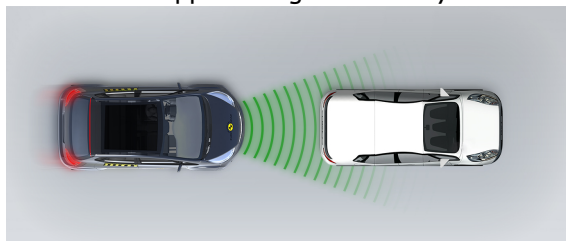
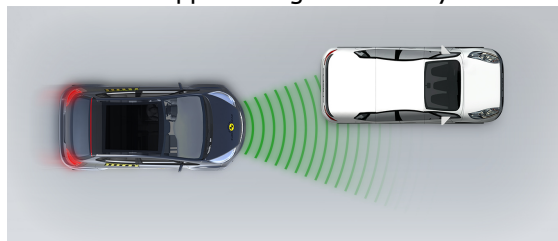
Approaching a stationary car
