Mercedes-Benz C-Class
Standard Safety Equipment

2022 ★★★★★

Tested Model	Mercedes-Benz C 180 AMG Line, LHD
Body Type	- 4 door saloon
Year Of Publication	2022
Kerb Weight	1625kg
VIN From Which Rating Applies	- #####
Class	Large Family Car

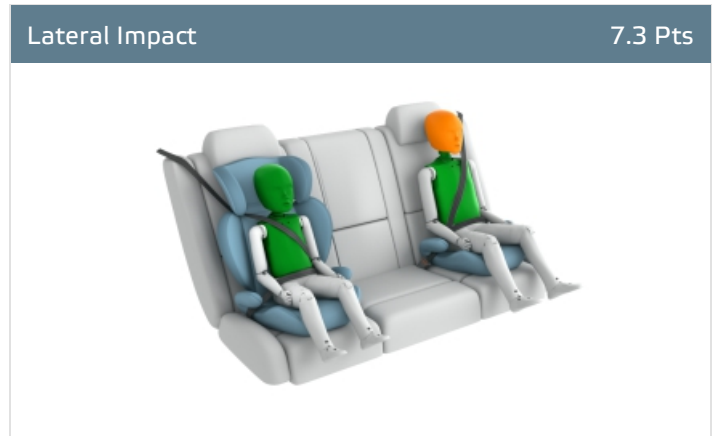
Crash Test Performance based on 6 & 10 year old children

22.7 / 24 Pts

Restraint for 6 year old child: *Britax Römer Kidfix*
 Restraint for 10 year old child: *Britax Römer Booster*

In the frontal offset test, good or adequate protection was provided to all critical body areas of both child dummies. In the side barrier test, protection of the head of the 10 year dummy was rated as marginal, based on measured accelerations, but that of all other body regions was good. The front passenger airbag is automatically disabled when a rearward-facing child restraint is put in that seating position. Tests showed that the system worked robustly and the system was rewarded. All of the child restraint types for which the car is designed could be properly installed and accommodated.
