Kia Niro
Standard Safety Equipment

2022

Tested Model	Kia Niro
Body Type	- 5 door SUV
Year Of Publication	2022
Kerb Weight	1682kg
VIN From Which Rating Applies	- all Niros
Class	Small Off-Road

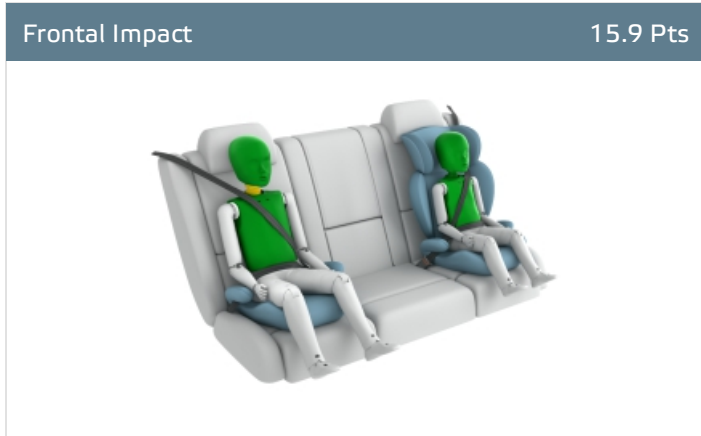
Crash Test Performance based on 6 & 10 year old children

22.2 / 24 Pts

Restraint for 6 year old child: *Britax Römer KidFix 2 R*
 Restraint for 10 year old child: *Graco Booster Basic / Junior III*

In the frontal offset test, protection of the 6 year dummy was good for all critical body areas and that of the 10 year dummy was good apart from adequate protection of the neck. In the side barrier test, dummy readings of acceleration in the head of the 10 year dummy revealed marginal protection of that body region, probably related to bottoming-out of the airbag, but protection of all other critical areas was good for both the 6 and 10 year dummies. The front passenger airbag can be disabled to allow a rearward-facing child restraint to be used in that seating position. Clear information is provided to the driver regarding the status of the airbag and the system was rewarded. All of the restraint types for which the Niro is designed could be properly installed and accommodated.

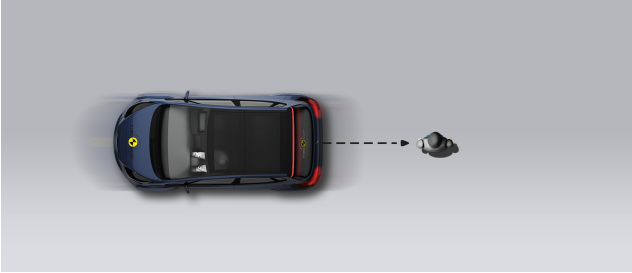
Vehicle reversing into standing pedestrian
