Opel/Vauxhall Combo
Standard Safety Equipment

2018

Tested Model	Peugeot Rifter BlueHDi 100 Allure, LHD
Body Type	- 5 door MPV
Year Of Publication	2018
Kerb Weight	1510kg
VIN From Which Rating Applies	- all Combos including Combo-e Life
Class	Small MPV

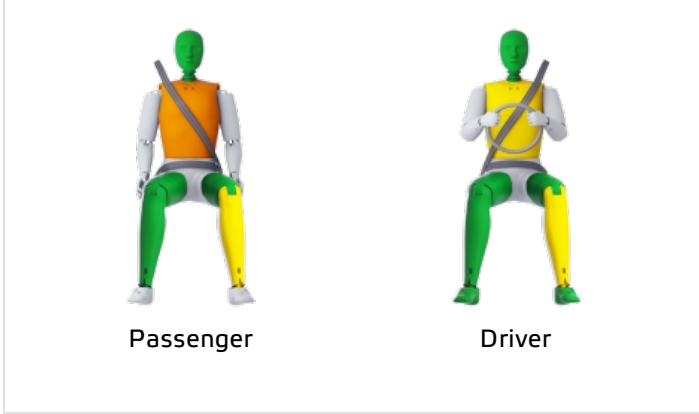
Frontal Offset Deformable Barrier 7 / 8 Pts

Detailed description: This panel shows two crash test dummies, one for the passenger and one for the driver, seated in a car. The passenger dummy is shown with a green torso and yellow legs, indicating a 'GOOD' result. The driver dummy is shown with a yellow torso and green legs, indicating an 'ADEQUATE' result.

The passenger compartment remained stable in the frontal offset test. Dummy readings showed good protection for the knees and femurs of both the driver and passenger. It was demonstrated that a similar level of protection would be provided to occupants of different sizes and to those sitting in different positions. In the full-width rigid barrier test, protection of the driver dummy was marginal for the chest and neck and good for other critical body areas. Protection of the rear passenger was good or adequate. In the side barrier test, protection of all critical body areas was good and the car scored maximum points. Even in the more severe side pole impact, protection of the chest was adequate and that of other critical body areas was good. Tests on the front seats and head restraints demonstrated good protection against whiplash injury in the event of a rear-end collision. A geometric assessment of the rear seats also indicated good whiplash protection. The standard-fit autonomous emergency braking (AEB) system performed well in tests of its functionality at the low speeds, typical of city driving, at which many whiplash injuries are caused.

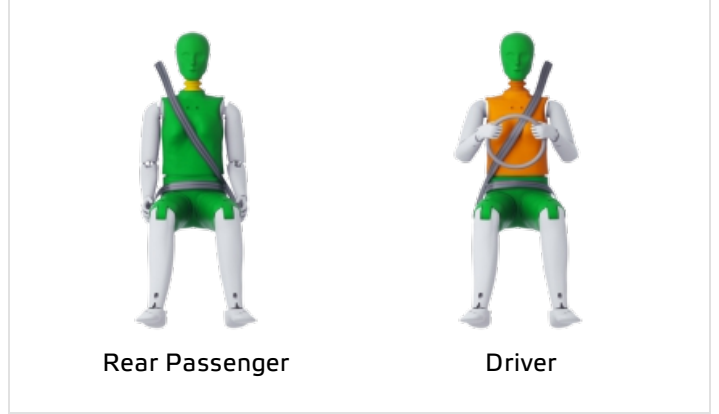
Frontal Full Width 7.2 / 8 Pts

Detailed description: This panel shows two crash test dummies, one for the rear passenger and one for the driver, seated in a car. The rear passenger dummy is shown with a green torso and green legs, indicating a 'GOOD' result. The driver dummy is shown with an orange torso and green legs, indicating a 'MARGINAL' result.

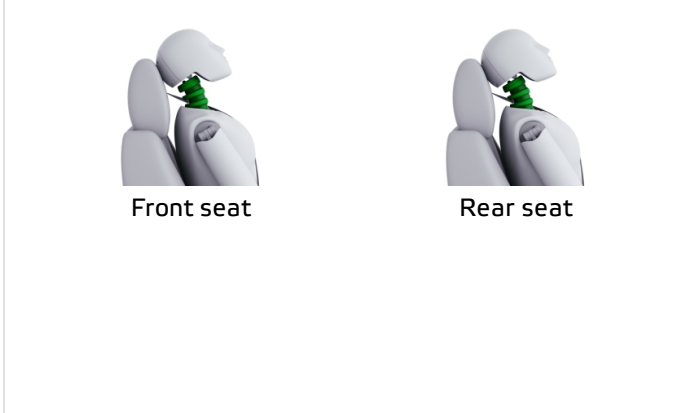
Whiplash Rear Impact 1.7 / 2 Pts

Detailed description: This panel shows two crash test dummies, one for the front seat and one for the rear seat, seated in a car. The front seat dummy is shown with a green neck and head, indicating a 'GOOD' result. The rear seat dummy is shown with a green neck and head, indicating a 'GOOD' result.

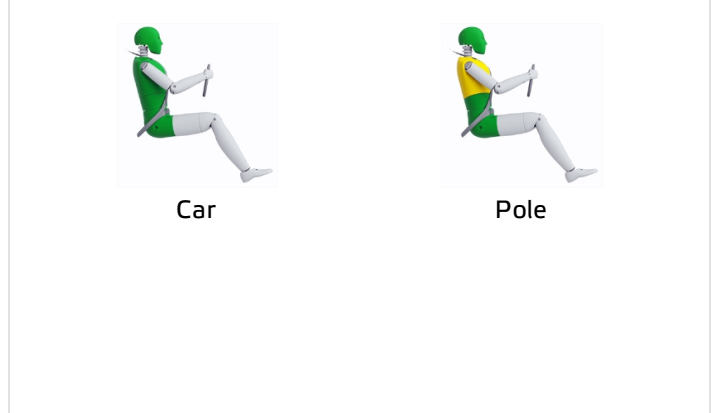
Lateral Impact 15.6 / 16 Pts

Detailed description: This panel shows two crash test dummies, one for the car and one for the pole, seated in a car. The car dummy is shown with a green torso and green legs, indicating a 'GOOD' result. The pole dummy is shown with a yellow torso and green legs, indicating an 'ADEQUATE' result.

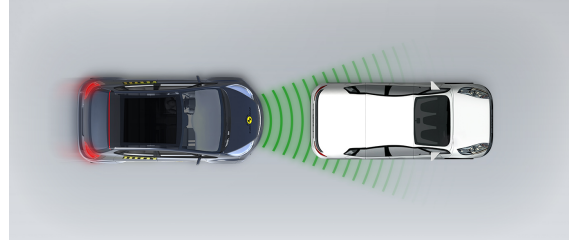
Approaching a stationary car: No Offset

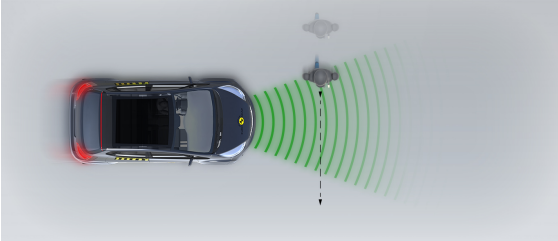
Adult crossing the road

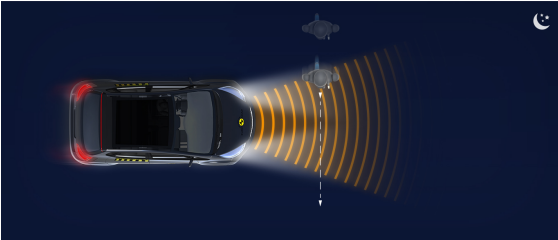
Adult crossing the road
