ISUZU D-Max Crew Cab
Standard Safety Equipment

2022

SPECIFICATION

Tested Model	Isuzu D-MAX Crew Cab 1.9 diesel, RHD
Body Type	- 4 door double cab
Year Of Publication	2022
Kerb Weight	2030kg
VIN From Which Rating Applies	- all D-MAX Crew Cabs
Class	Pick-up

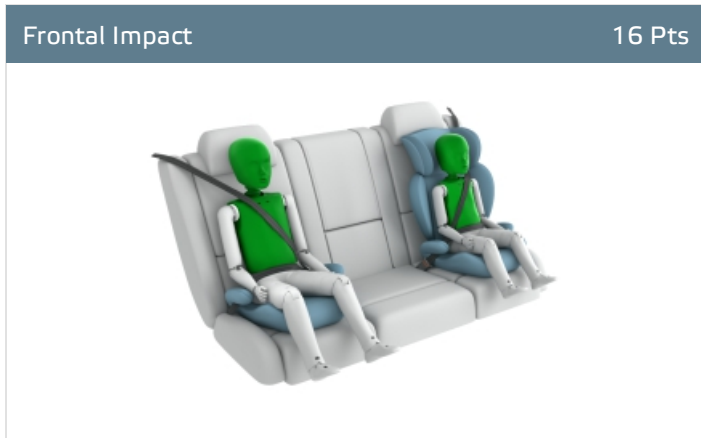
Crash Test Performance based on 6 & 10 year old children

Restraint for 6 year old child: *KidFix i-Size*
 Restraint for 10 year old child: *Graco Booster*

In both the frontal offset test and the side barrier impact, protection of both child dummies was good for all critical body areas and the D-MAX scored maximum points in this part of the assessment. The front passenger airbag can be disabled to allow a rearward-facing child restraint to be used in that seating position. Clear information is provided to the driver regarding the status of the airbag and the system was rewarded. With the exception of one i-Size restraint in the rear outboard seats, all of the restraints for which the D-MAX is designed could be properly installed and accommodated.
