Volvo EX30
Standard Safety Equipment

2024

SPECIFICATION

Tested Model	Volvo EX30 Plus, Single Motor Extended Range
Body Type	- 5 door SUV
Year Of Publication	2024
Kerb Weight	1775kg
VIN From Which Rating Applies	- all EX30s
Class	Small SUV

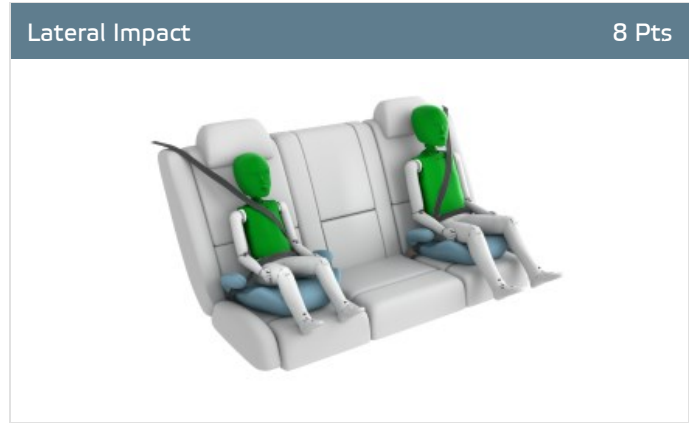
24.0 / 24 Pts

Crash Test Performance based on 6 & 10 year old children

Restraint for 6 year old child: *Volvo Booster Seat*
 Restraint for 10 year old child: *Volvo Booster Cushion*

In both the frontal offset and side barrier tests, protection of all critical parts of the body was good for the 6 and 10 year dummy, and the Volvo EX30 scored maximum points in this part of the assessment. The front passenger airbag can be disabled to allow a rearward-facing child restraint to be used in that seating position. Clear information is provided to the driver regarding the status of the airbag, and the system was rewarded. The EX30 is not equipped with a 'child presence detection' system, which issues a warning when it recognises that a child or infant may have been left in the car. All of the child restraint types for which the Volvo EX30 is designed could be properly installed and accommodated in the car, apart from the iSize restraint in the rear centre position.
